Hawaiian Steam Engineering Co.

Analysis of Boiler Tube Failures Union Pacific RR Steam Locomotive #844 June 24, 1999 Sacramento, California

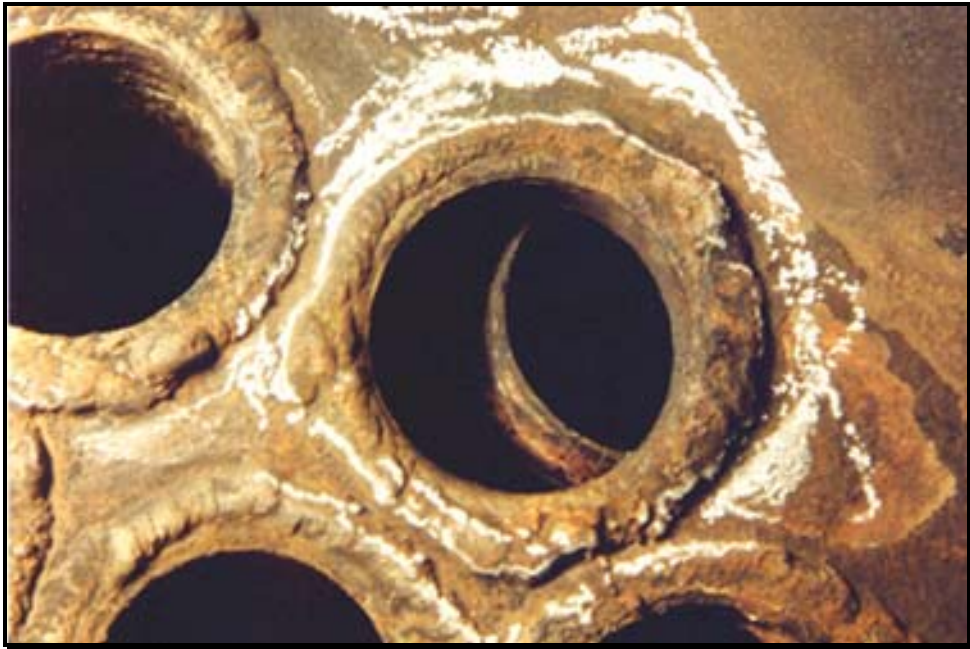
Photo "A"

Tube in upper quadrant on engineer's side that failed completely.

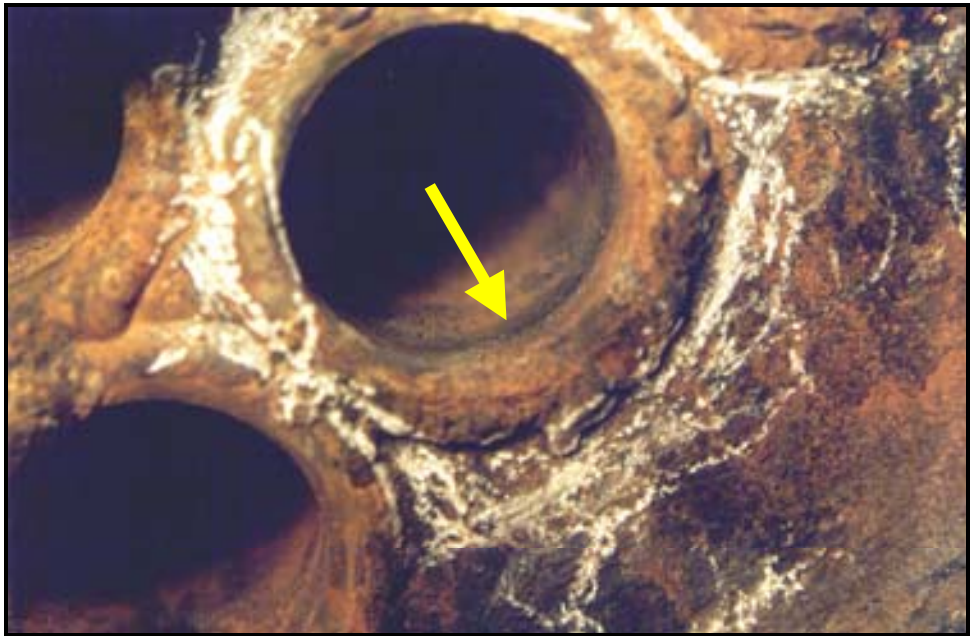
Photo "B"

Tube in lower quadrant engineer's side that partially failed. Arrow indicates opening in tube wall, circumferential crack.

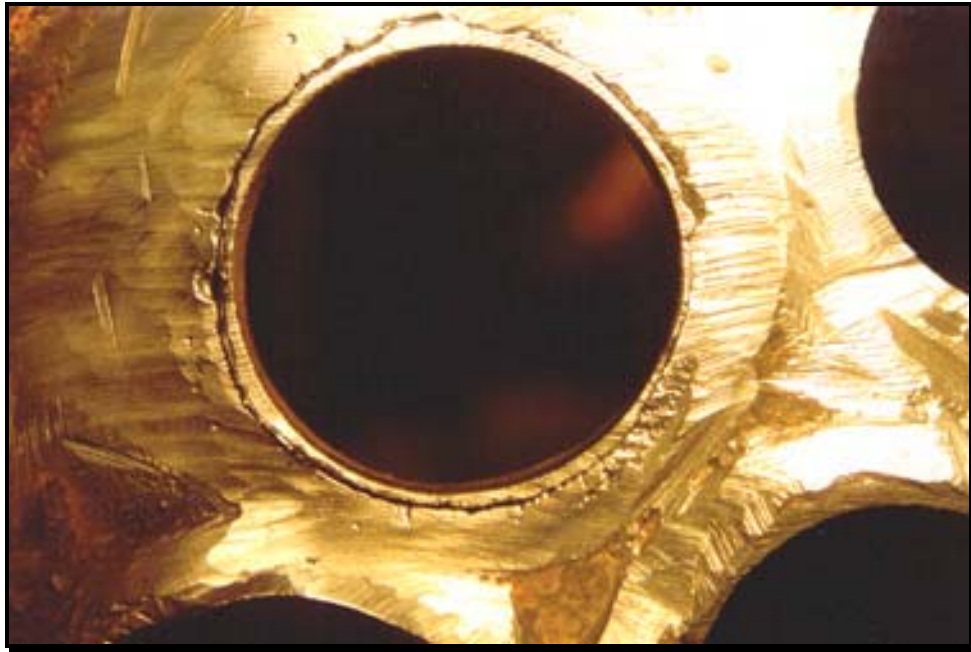
Photo "C"

Completely failed tube lower fireman's side. Seal weld was ground off flush with tube sheet to provide indication of extent of crevice corrosion.

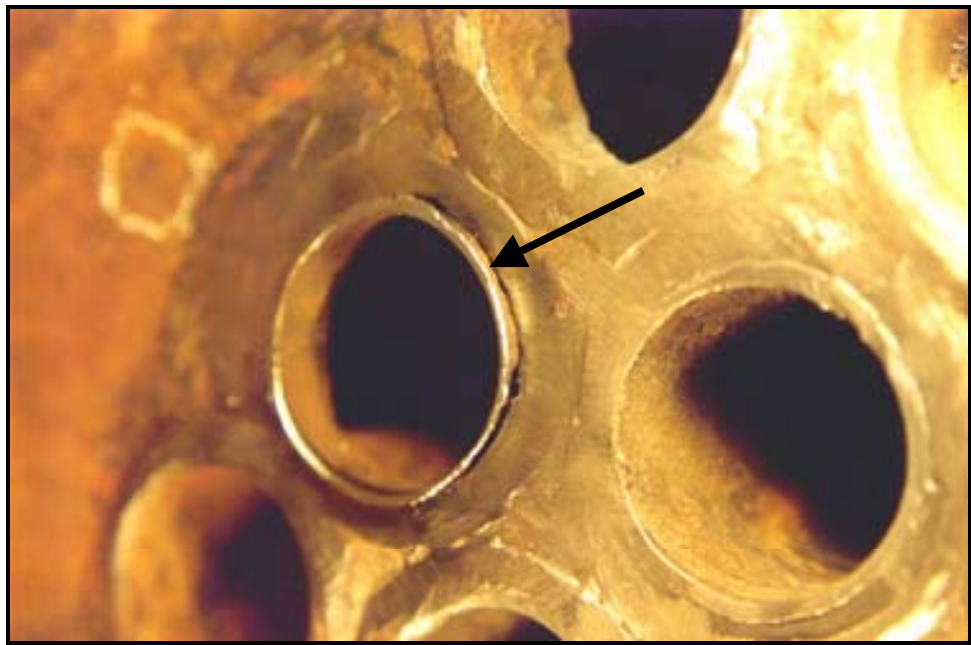
Photo "D"

Usually tight in tube sheet, rolled stubs are typically removed with torch or air tool. This was less than finger tight.

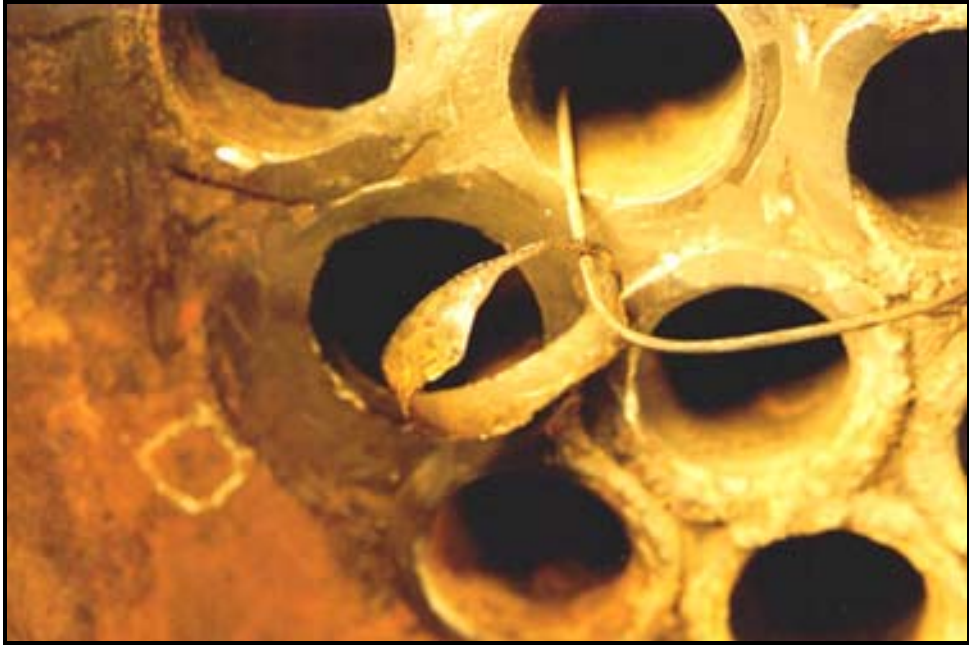
Photo “E”

Tube stub end removed from tube sheet.

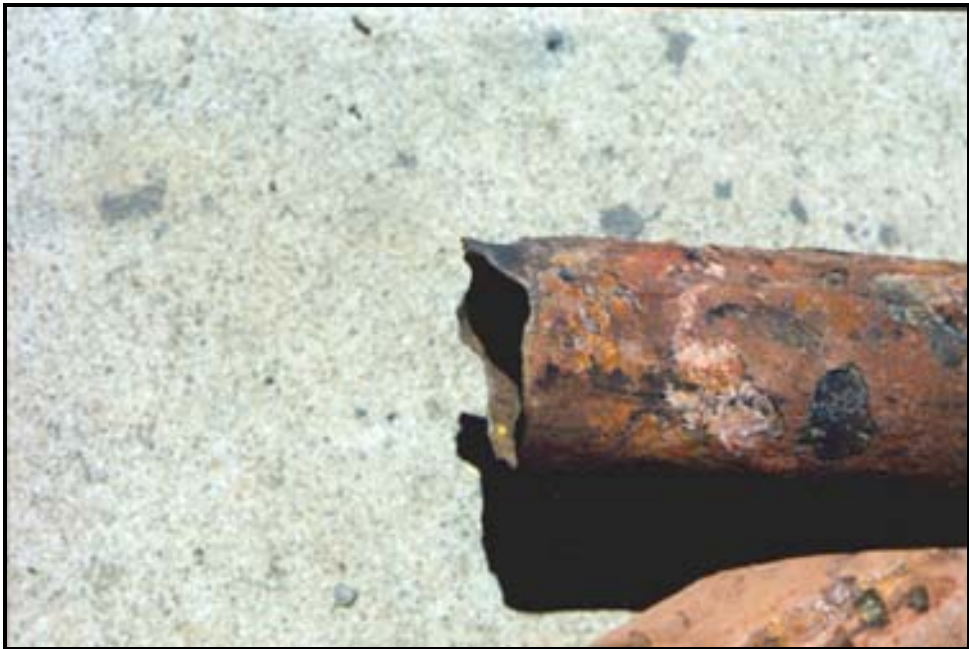
Photo “F”

Mating tube to that of stub shown in Photo “E”.

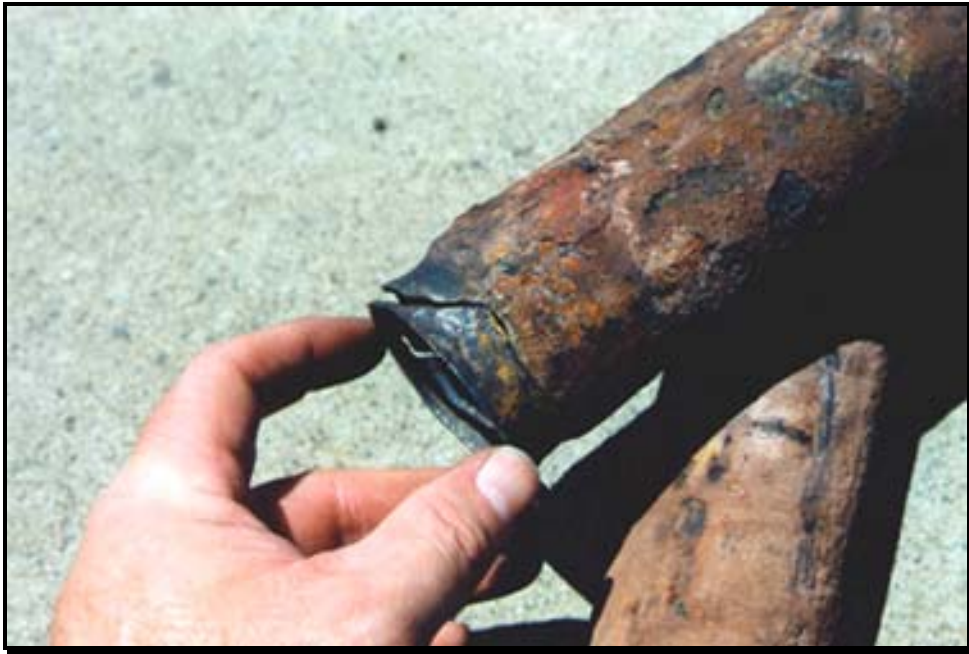
Photo “G”
Mating stub end to tube end.

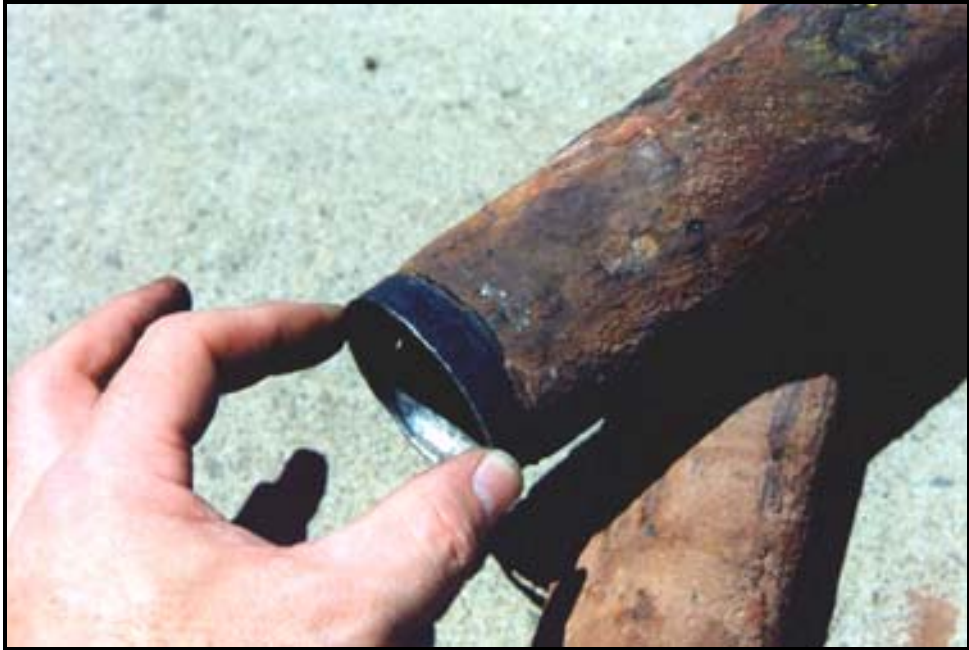
Photo “H”
Note black iron oxide on portion of stub end.

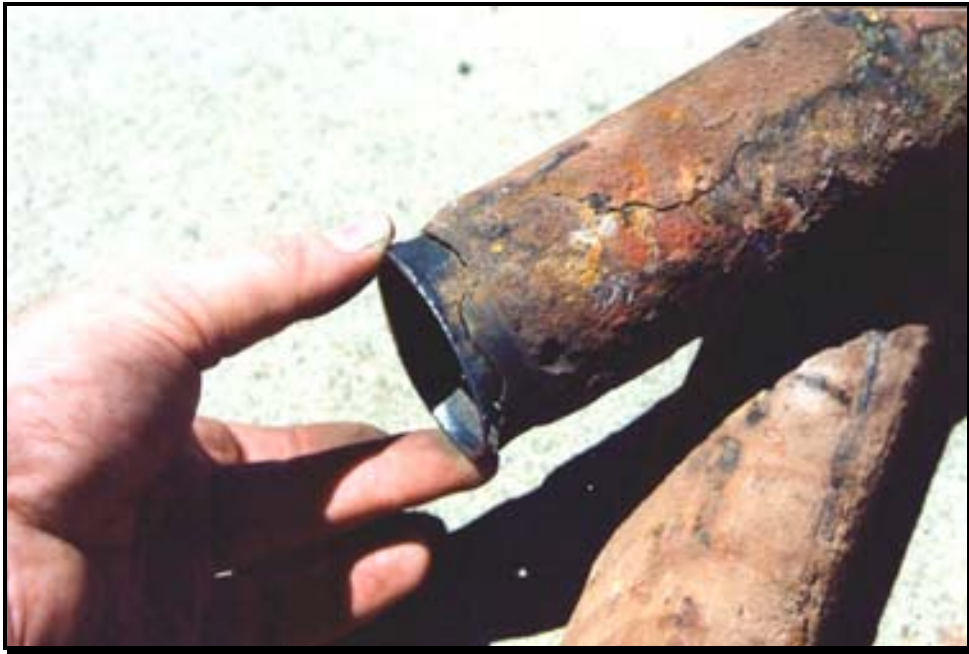
Photo "I"

Extensive thinning of tube wall adjacent to tube sheet and in tube sheet area is visibly noticeable.

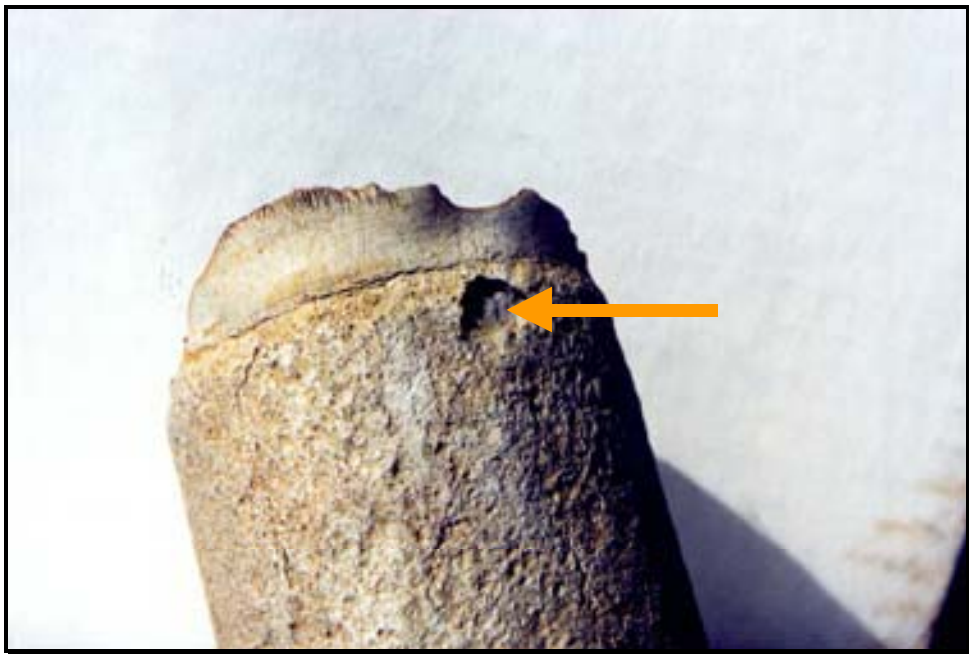
Photo "J"

Classic oxygen cell corrosion approximately $\frac{1}{4}$ " diameter. Tube has been descaled by chemical cleaning.

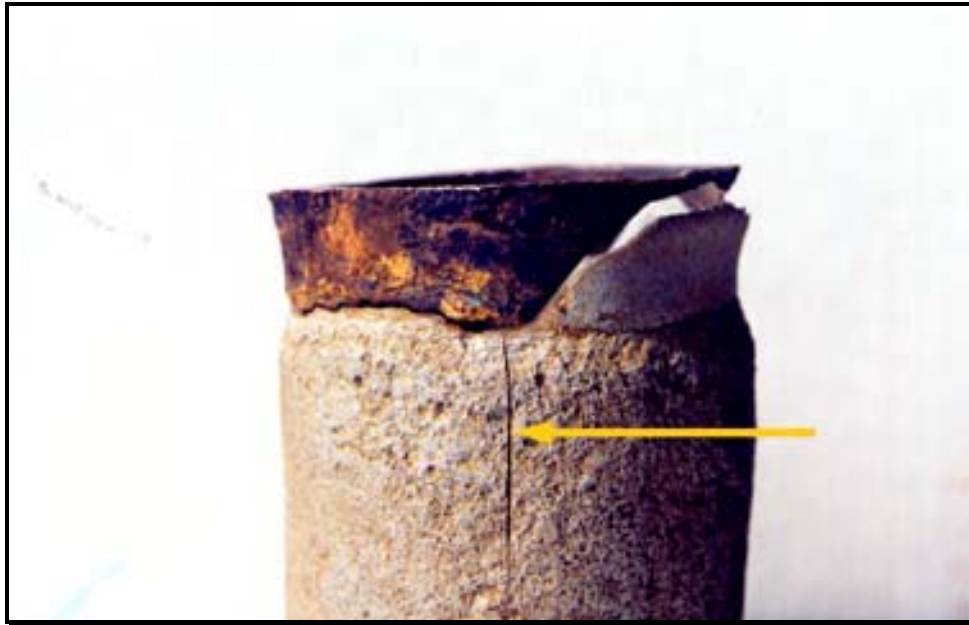
Photo “K”

Electric resistance welded (ERW) seam beginning to degrade due to corrosion.

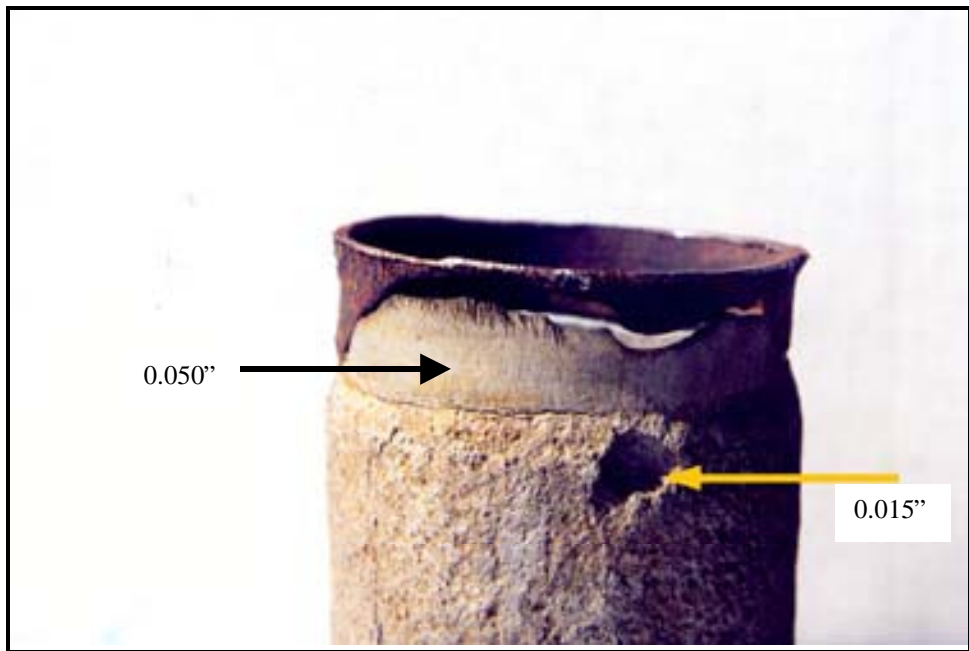
Photo “L”

Thickness at bottom of pit is 0.015". Thickness at tube seat still attached to tube average is 0.050". Average thickness of tube wall for 3" from tube sheet is approximately 0.120".
